**MAYFIELD ROAD  
CLASS ENVIRONMENTAL ASSESSMENT AND PRELIMINARY DESIGN STUDY  
HEART LAKE ROAD TO AIRPORT ROAD**

## **APPENDIX F**

**Culvert Survey Information  
Region of Peel, May 2002**

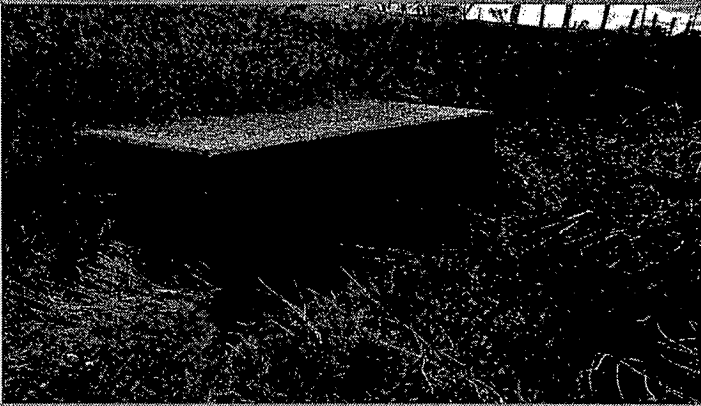
Elevation:

Mayfield Road 0.3 km West of Airport Road, #7
<b>Year Built:</b>	1960
<b>Bridge Type:</b>	Reinforced Concrete Box Culvert - Open Footing
<b>Crosses:</b>	West Humber River Tributary
<b>Direction of Traffic:</b>	WE
<b>Number of Lanes:</b>	2
<b>Number of Cells:</b>	1
<b>Number of Barriers:</b>	2
<b>Watercourse:</b>	Yes
<b>Inspector:</b>	Warren Lopes
<b>Date of Survey:</b>	5/17/2002 2:58:39 PM
<b>Physical Testing</b>	
<b>Inspector Comments:</b>	No Comments
Enter Comments Here:	<div style="border: 1px solid #ccc; height: 80px; width: 100%;"></div>

Culvert Type:	Reinforced Concrete Box Culvert - Open Footing
Evidence of Failure:	N
Extent of Alkali Aggregate:	None
Extent of Cracking:	Local
Severity of Cracking:	Light
OHBDC Conformance:	Meets Code
Are cracks leaching:	Y
Length of Cracking requiring repair (in metres):	0
% of Cracking requiring Repair which is Structurally related:	
Compressive Strength	Greater Than 35 Mpa
Air Void Distribution	Satisfactory
% Horizontal Repair Area:	0
% Vertical Repair Area:	0
% Underside Repair Area:	0
Remaining Service Life:	15
<b>Dimensional Data</b>	
Horizontal exposed surface area (in metres <sup>2</sup> ):	3.74
Horizontal slab length (in metres):	22
Horizontal slab thickness (in metres):	0.3
Horizontal slab width (in metres):	3.4
Overburden (in metres):	1.6
Vertical exposed surface area (in metres <sup>2</sup> ):	0.78
Vertical wall height (in metres):	0.6
Vertical wall length (in metres):	22
Vertical wall thickness (in metres):	0.3

Watercourse Stability:	Stable
Significant Erosion of Banks Evident:	N
Evidence of Unanticipated Flow Exposure:	N
Length Requiring Non-Critical Repair (in metres):	0
Length Requiring Critical Repair (in metres):	0
Remaining Service Life:	15
<b>Dimensional Data</b>	
Bank 1 Length of impact (in metres):	3
Bank 2 Length of impact (in metres):	3
