Appendix M – Structural Assessment Report

Schedule “C” Class Environmental Assessment for Airport
Road from Braydon Boulevard / Stonecrest Drive to
Countryside Drive

Project: Airport Road Environmental Assessment Study (Braydon Boulevard/Stonecrest Drive to Countryside Drive)

Subject: Airport Road Structural Assessment at Tributary B and Tributary C of the West Humber River

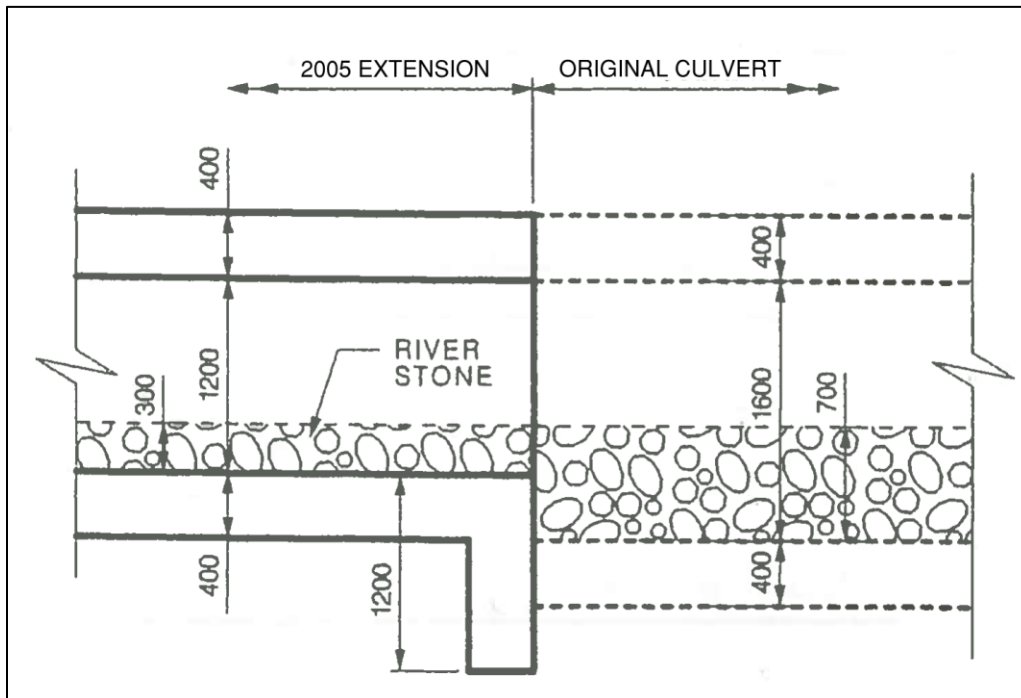
Figure 2: Original Tributary B Culvert and 2005 Extension

The original culvert was constructed sometime before 2005 and consisted of a 4500x1600mm box section, 65.6m in length and included 0.7m embedment. As part of the Airport Road widening from two to four lanes undertaken in 2005 under Peel Region contract 01-4035, the original culvert was extended on the west side of Airport Road by a distance 32.4m to accommodate the roadway widening at that time. It is noted that the hydraulic opening from the original culvert (900mm) is consistent with the hydraulic opening from the 2005 extension (refer to **Figure 2**).

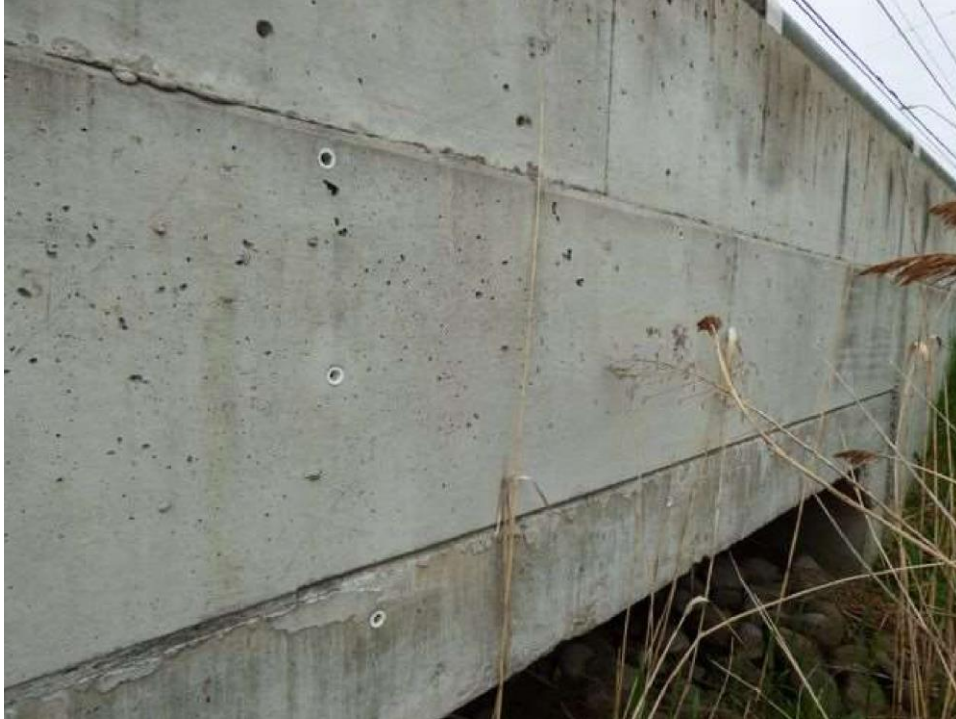
Tributary B – Elevation at the inlet

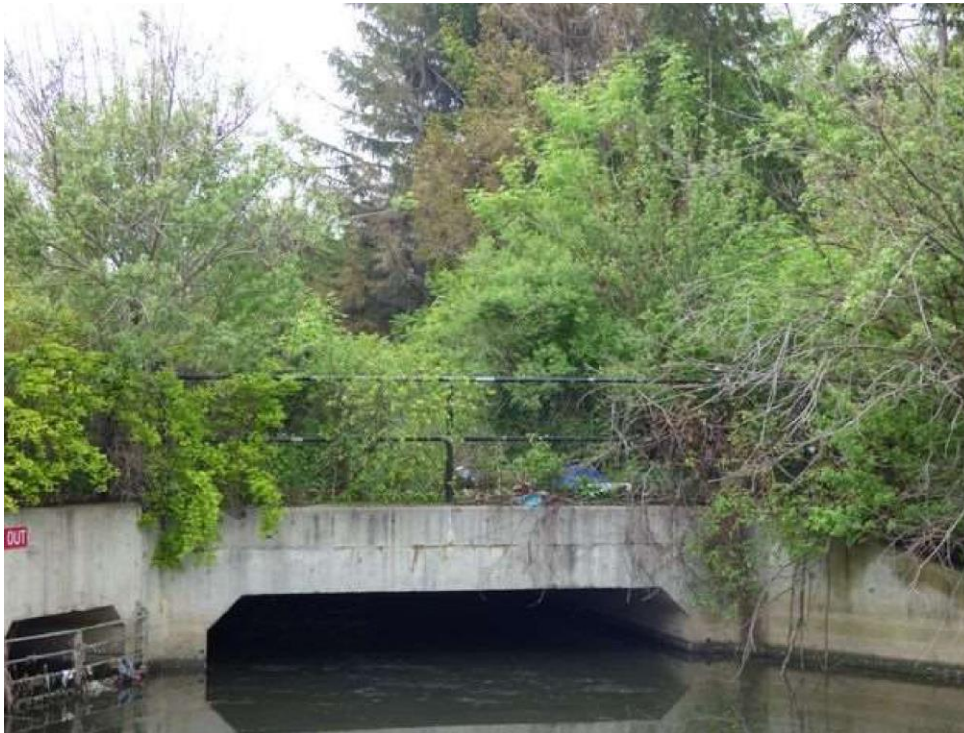
Tributary B – Elevation at the outlet

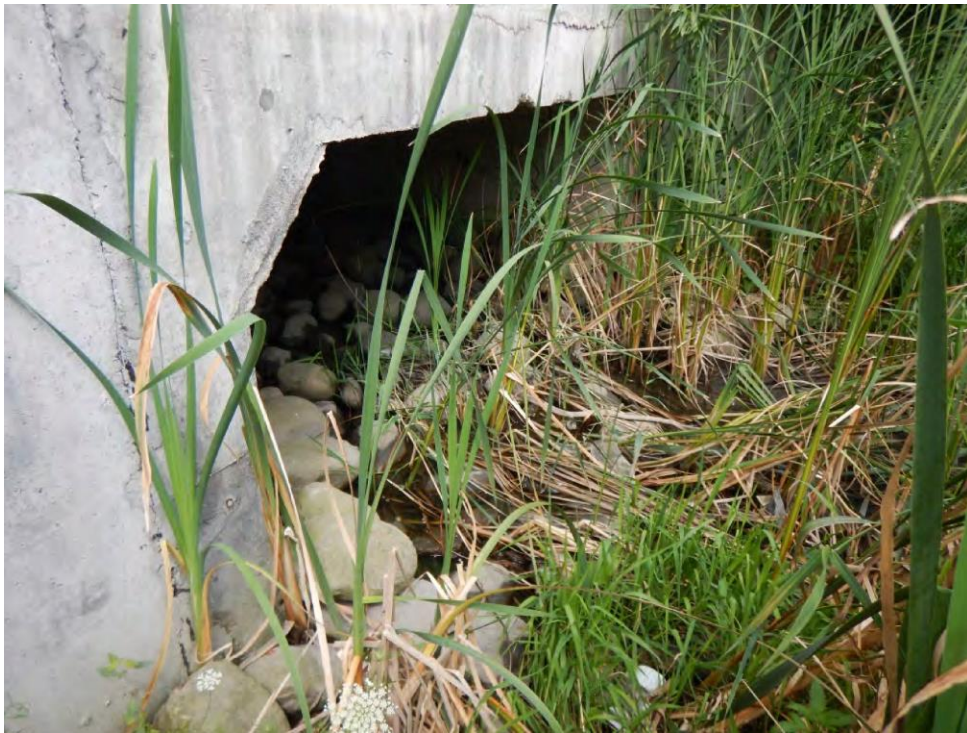
A biennial inspection was not available for this structure at the time of the Airport Road EA. Observations from the visual inspection conducted by HDR staff as part of the Airport Road EA noted that the existing structure appears to be in good condition and no visible deterioration including exposed reinforcement or concrete cracks were observed at the inlet or outlet. However, minor spalling was observed at the inlet which can be addressed with minor rehabilitation works. No major structural upgrades are anticipated based on the findings of the existing condition review. Peel Region will be conducting OSIM investigations for this culvert as part of a separate undertaking and the findings should be reviewed and considered during the detailed design of Airport Road.

Tributary C – Elevation at the outlet

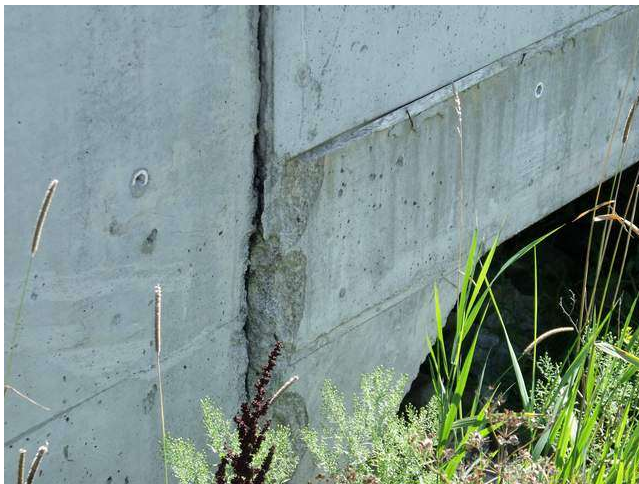
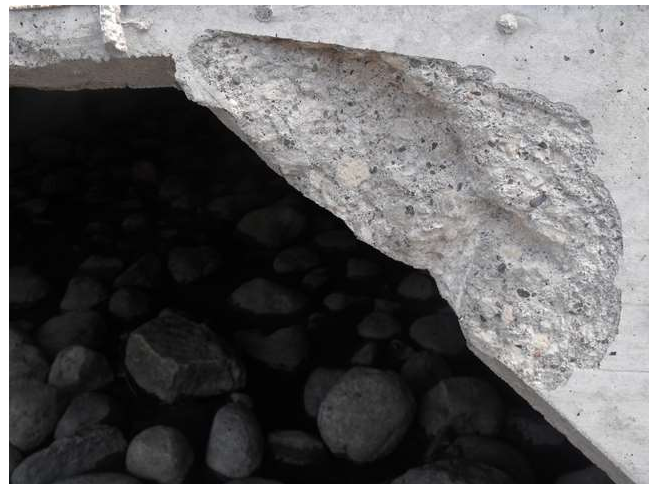
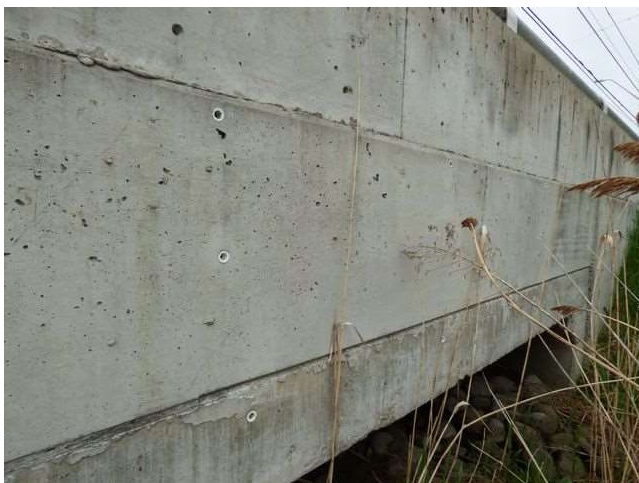
The exterior surface (end) has an area of 0.3 square metres. The entire element exhibits medium disintegration requiring surface repair.

Condition Data:	Units	Exc.	Good	Fair	Poor	Performance Deficiencies	Maintenance Needs
	m2	0	0	0	0.3	00	00

Barrel - Exterior Surface - (End)
Surface Repair

Urgency : **None** 6-10 years 1-5 years < 1 year Urgent
 Recommended Work : **Surface Repair**

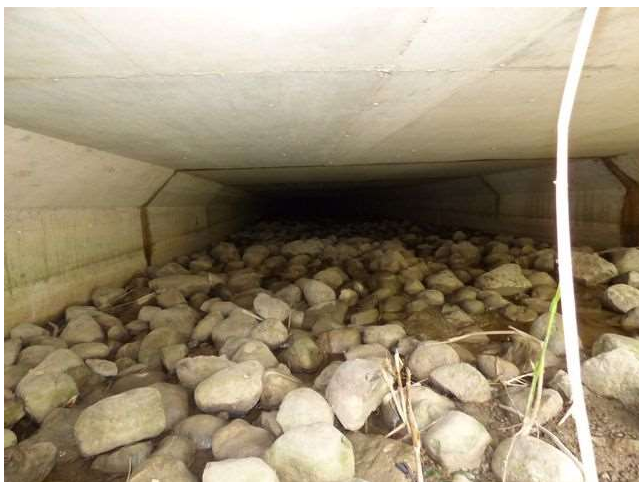
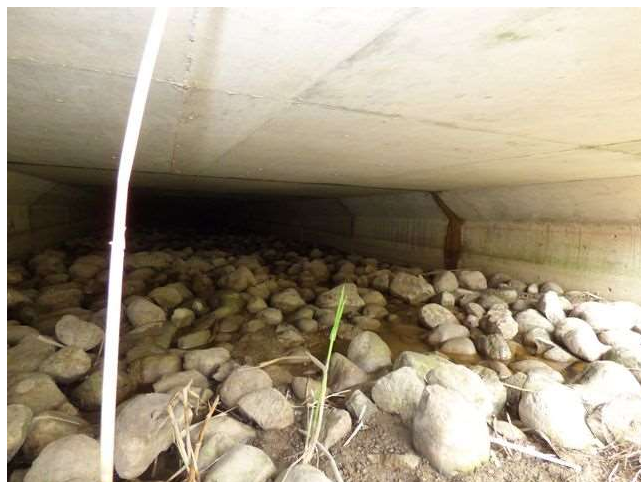
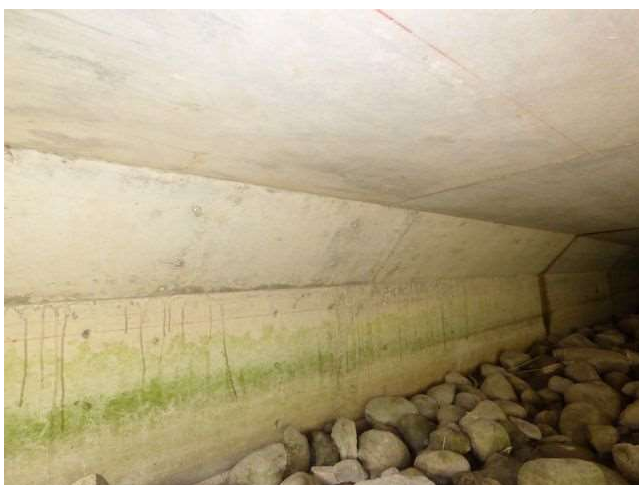
Comments: Barrel leakage between precast concrete joints is evident. Note: limited inspection due to low clearance.

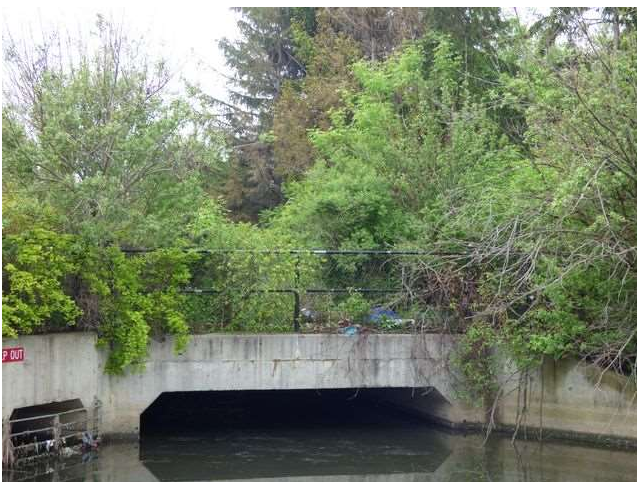
East Elevation

Comments: The interior barrel shows signs of leakage at precast joints and therefore waterproofing should be applied to the exterior barrel to prevent future leakage.

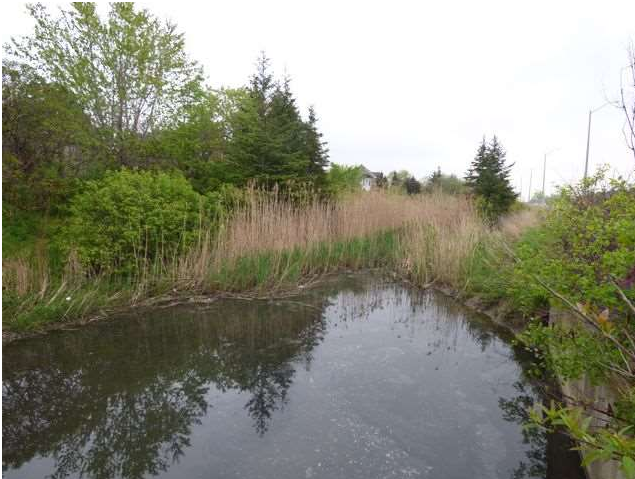
Overall View

Element Group:	Watercourse					Length:	N/A	
Element Name:	Watercourse					Width:	N/A	
Location:	Single Element					Height:	N/A	
Material:	Any					Count:	1	
Element Type:	Straight					Total Quantity:	1	
Environment:	Moderate					Limited Inspection	<input checked="" type="checkbox"/>	
Protection System:	None							
Condition Data:	Units	Exc.	Good	Fair	Poor	Performance Deficiencies	Maintenance Needs	
	all	0	0.6	0.4	0	00	18	
Comments:	Seasonal maintenance should be performed to ensure no blockages occur.

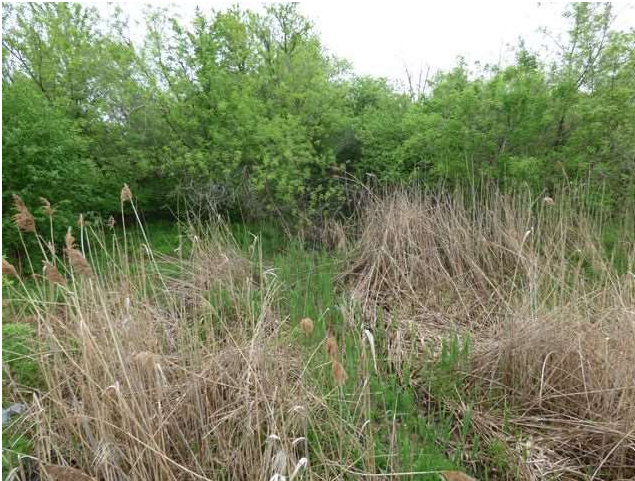
Overall View

Observed Defect: Medium Aggradation

Element Group:	Watercourse				Length:	N/A	
Element Name:	West Upstream Section				Width:	N/A	
Location:	West				Height:	N/A	
Material:	Paving Stones				Count:	N/A	
Element Type:	Controlled				Total Quantity:	254	
Environment:	Moderate				Limited Inspection	<input checked="" type="checkbox"/>	
Protection System:	None					Performance Deficiencies	Maintenance Needs
Condition Data:	Units	Exc.	Good	Fair	Poor		
	m2	0	127	127	0	00	02

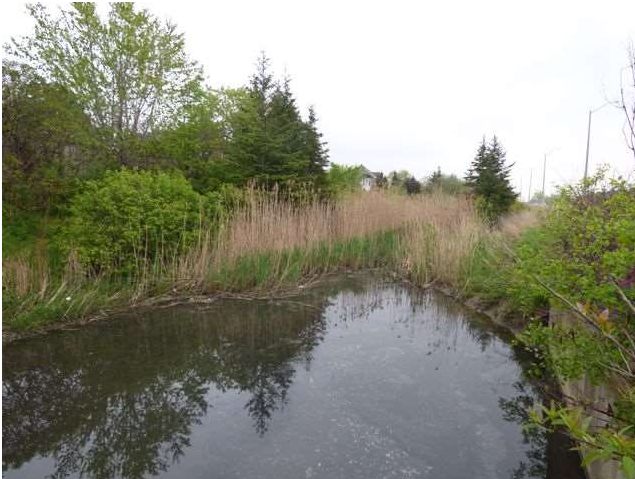
Overall View

Observed Defect: Medium Aggradation

Element Group:	Watercourse				Length:	N/A	
Element Name:	East Downstream Section				Width:	N/A	
Location:	East				Height:	N/A	
Material:	Paving Stones				Count:	N/A	
Element Type:	Controlled				Total Quantity:	254	
Environment:	Moderate				Limited Inspection	<input checked="" type="checkbox"/>	
Protection System:	None					Performance Deficiencies	Maintenance Needs
Condition Data:	Units	Exc.	Good	Fair	Poor		
	m2	0	127	127	0	00	02
