**Stage 3 Archaeological Assessment (Cemetery Investigation)**

**Shiloh Primitive Methodist Cemetery**

**Lot 17, Concession 12 ND (Regional Road 50)  
Former Township of Toronto Gore, Peel County  
City of Brampton, Regional Municipality of Peel**

Archaeological Licence P094 (Lisa Merritt)  
MCL PIF P094-097-2011  
ASI File 11EA-102

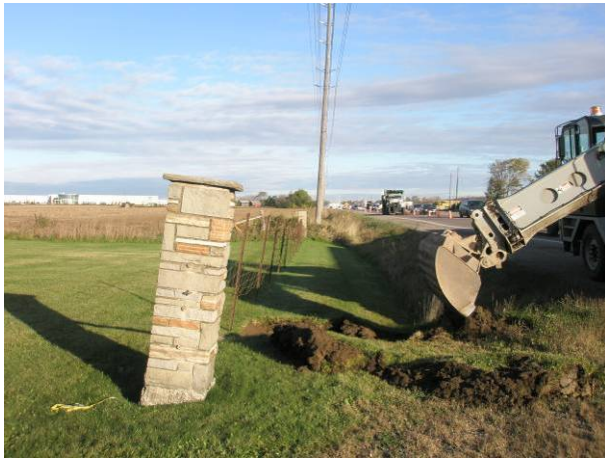
Plate 1: North-northwest view of the study area. Gradall trenching in progress. Note the stone posts that mark the eastern boundary of the cemetery.

In 1901 the congregations of Shiloh, and Zoar decided to unite and build a new church at a site 0.8 km to the south on the southwest corner of Highway 50 and Countryside Drive. The original Shiloh Church and horse sheds were demolished the following year. The cemetery was badly neglected in the beginning of the 1900s until a board of trustees was formed in 1930 and a fund established to care for the grounds (Region of Peel Archives n.d.). When Highway 50 was originally widened, the Ontario Department of Highways built stone posts at the eastern limit of the cemetery (Plate 1).

A Stage 3 Cemetery investigation was recommended because historic cemeteries often contain unmarked burials beyond current boundaries. Over time the boundaries of these cemeteries, particularly those beside busy roadways, often “shrink” to accommodate road widening and the pressure of modern development. In this case, the Shiloh Cemetery was established in the 1840s and is situated on the west side of Highway 50, approximately 725 metres south of Mayfield Road. Stone posts mark the eastern limits of the cemetery (Plate 1).

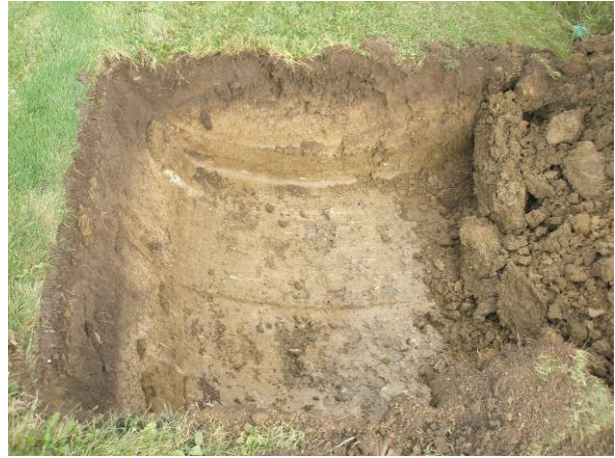
Plate 2: West view of sterile soil in trench wall. Clayey-loam topsoil and orangey brown subsoil.

(0.75 m – 0.95 m). Once the trench was opened up, the wall profiles and trench floor were checked for any signs of disturbances from possible graves related to the Shiloh cemetery (Plates 2-3). Although there were some signs of soil disturbance in the top soil level, there was no evidence of grave shafts observed in the undisturbed subsoil layer.

The soil in the 33 m long trench was very uniform and was observed as follows: from 0-6 cm was a sod layer, from 6-35 cm was a mottled medium brown and orange clayey loam layer, and from 45-95 cm was orangey brown clay. In spite of careful observation no evidence of any burial shafts were found in the ROW adjacent to the Shiloh Cemetery.

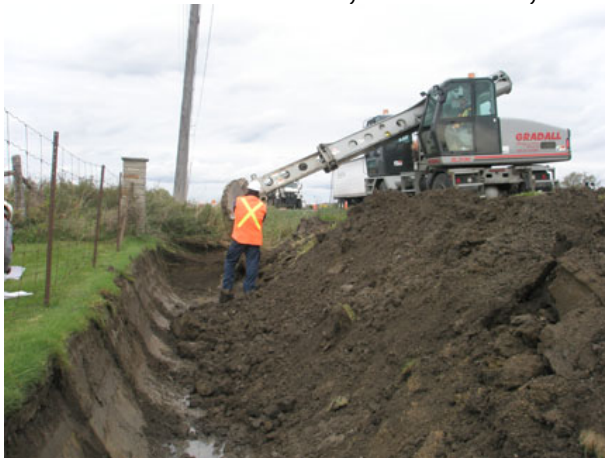
Plate 3: North-northwest view of trench and profile of west wall. All soil is sterile with no evidence of burials in ROW.
