Appendix M – Structural Assessment Report

Schedule “C” Class Environmental Assessment for Airport
Road from Braydon Boulevard / Stonecrest Drive to
Countryside Drive

Project: Airport Road Environmental Assessment Study (Braydon Boulevard/Stonecrest Drive to Countryside Drive)

Subject: Airport Road Structural Assessment at Tributary B and Tributary C of the West Humber River

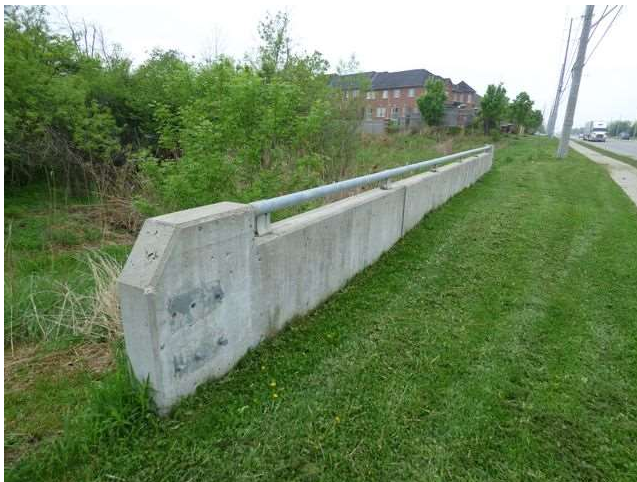
East View

Element Group:	Over Burden			Length:	10		
Element Name:	Over Burden			Width:	88		
Location:	Single Element			Height:	1.46		
Material:	Soil			Count:	1		
Element Type:	Primary Element			Total Quantity:	1		
Environment:	Moderate			Limited Inspection	<input checked="" type="checkbox"/>		
Protection System:	None						
Condition Data:	Units	Exc.	Good	Fair	Poor	Performance Deficiencies	Maintenance Needs
	each	0	1	0	0	00	00
Comments:	None.						
Urgency :	None <input checked="" type="checkbox"/>	6-10 years <input type="checkbox"/>	1-5 years <input type="checkbox"/>	< 1 year <input type="checkbox"/>	Urgent <input type="checkbox"/>		
Recommended Work :	None

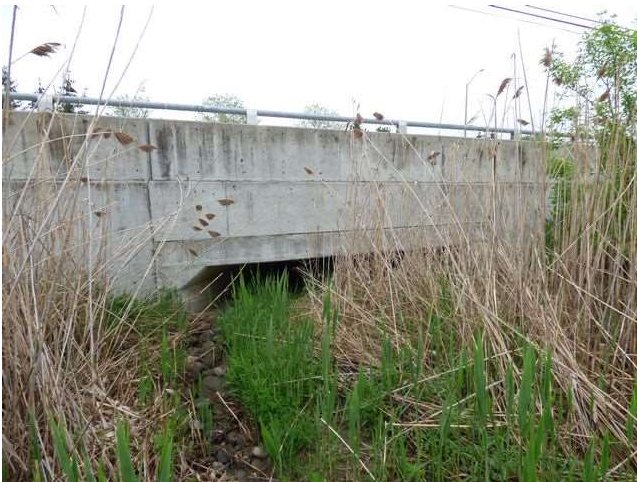
West View

The cast-in-place barrel has an estimated mass of 641 tonnes. An estimated 1% of the element exhibits medium general deterioration. The estimated remaining service life in its current condition is 10 years.

Element Group:	Barrel			Length:	N/A		
Element Name:	Barrel			Width:	N/A		
Location:	Single Element			Height:	N/A		
Material:	Cast-In-Place Concrete			Count:	N/A		
Element Type:	Primary Element			Total Quantity:	640.8		
Environment:	Moderate			Limited Inspection	<input checked="" type="checkbox"/>		
Protection System:	None					Performance Deficiencies	Maintenance Needs
Condition Data:	Units	Exc.	Good	Fair	Poor		
	tonnes	627.98	0	12.82	0	00	00
Comments:	None.						
Urgency :	None <input type="checkbox"/>	6-10 years <input checked="" type="checkbox"/>	1-5 years <input type="checkbox"/>	< 1 year <input type="checkbox"/>	Urgent <input type="checkbox"/>		
Recommended Work :	Defer to Element Level

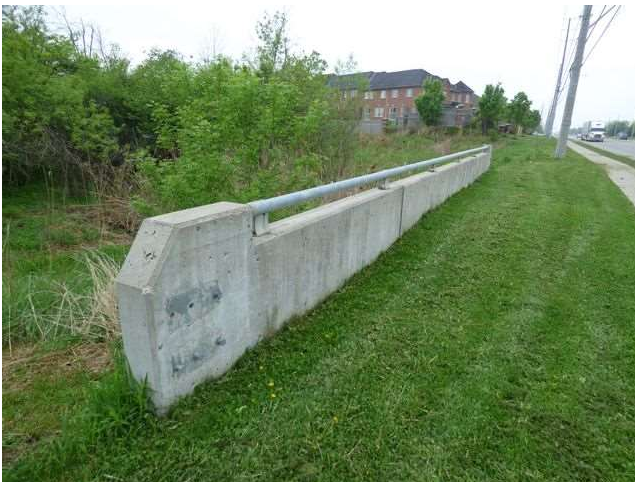
Overall View

Element Group:	Barrier			Length:	N/A		
Element Name:	InteriorBarrier			Width:	N/A		
Location:	Interior			Height:	N/A		
Material:	Steel			Count:	N/A		
Element Type:	Primary Element			Total Quantity:	0.1		
Environment:	Severe			Limited Inspection	<input type="checkbox"/>		
Protection System:	Galvanized Steel						
Condition Data:	Units	Exc.	Good	Fair	Poor	Performance Deficiencies	Maintenance Needs
	tonnes	0.1	0	0	0	00	02
Comments:	None.						
Urgency :	None <input checked="" type="checkbox"/>	6-10 years <input type="checkbox"/>	1-5 years <input type="checkbox"/>	< 1 year <input type="checkbox"/>	Urgent <input type="checkbox"/>		
Recommended Work :	None

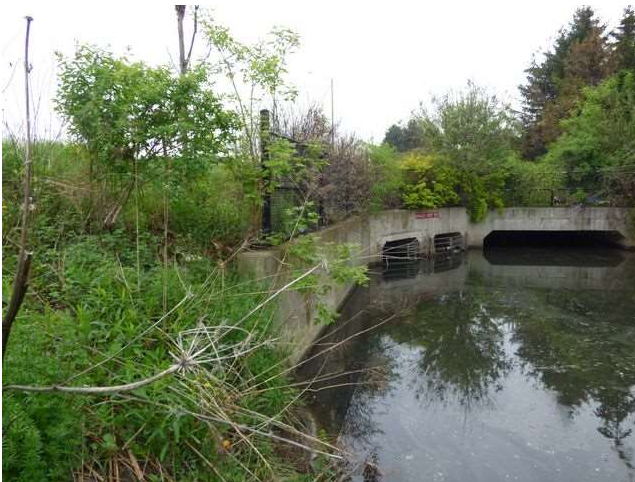
Overall View

Element Group:	Retaining Wall			Length:	N/A		
Element Name:	SouthRetaining Wall			Width:	N/A		
Location:	South			Height:	N/A		
Material:	Cast-In-Place Concrete			Count:	N/A		
Element Type:	Primary Element			Total Quantity:	7.6		
Environment:	Moderate			Limited Inspection	<input checked="" type="checkbox"/>		
Protection System:	None						
Condition Data:	Units	Exc.	Good	Fair	Poor	Performance Deficiencies	Maintenance Needs
	tonnes	7.6	0	0	0	00	00
Comments:	None.						
Urgency :	None <input checked="" type="checkbox"/>	6-10 years <input type="checkbox"/>	1-5 years <input type="checkbox"/>	< 1 year <input type="checkbox"/>	Urgent <input type="checkbox"/>		
Recommended Work :	None
